NSWCCD-TR-61—97/10

Survivability, Structures, and Materials Directorate  
Technical Report

## SEM Stereo-Section Fractography Observations

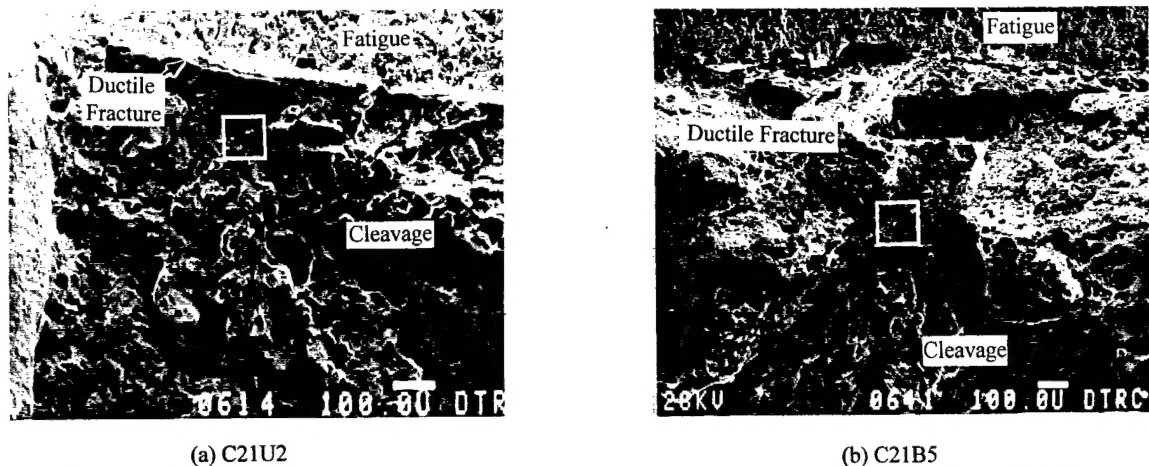
A group of nine  $\frac{1}{2}$ T SENB specimens ( $B = 25.4$  mm) of A533B steel were tested at  $-6.7^{\circ}\text{C}$  and the J-integral values at cleavage ( $J_c$ ) exhibited wide scatter.<sup>6</sup> The lowest  $J_c$  was  $61 \text{ m-kN/m}^2$  ( $348 \text{ in-lbs/in}^2$ ) for specimen C21U2 while the highest  $J_c$  was  $306 \text{ m-kN/m}^2$  ( $1750 \text{ in-lbs/in}^2$ ) for specimen C21B5. Low magnification SEM fractographs of the two specimens (Figures 2a-2b) illustrate a significant difference in ductile fracture width between the two specimens which reflects these  $J_c$  differences. The inlayed box in each figure identifies the main cleavage initiation region (MCIR). A transverse section (as in Figure 1) was created a few microns away from the cleavage initiation site (CIS) in each specimen. The section was then etched and imaged optically (Figures 3a- 3b) to reveal the adjacent microstructure. The fatigue precrack tip, ductile zone width, and cleavage initiation site are indicated for each specimen in these figures. Their precise locations have been maintained here by tilting the specimen to reveal both the fracture surface and microstructure, identifying distinguishing features on each surface, and then slowly tilting the specimen until the transverse section is normal to the imaging beam. It is then clearly evident that the narrower ductile fracture zone and subsequent rapid onset of cleavage observed in specimen C21U2 is associated with the relatively brittle, dark carbide band. Conversely, the wider ductile fracture zone and higher toughness of specimen C21B5 is

associated with a relatively ductile, lower carbon region. The underlying microstructure explains the substantial spread of  $J_c$  in these specimens, but it even more clearly demonstrates Irwin's conjecture that cleavage initiation is a local event which is sensitive to microstructural variation within the material.\*

Figure 2: SEM fractographs showing a substantial difference in ductile fracture extension between specimens (a) C21U2 and (b) C21B5.

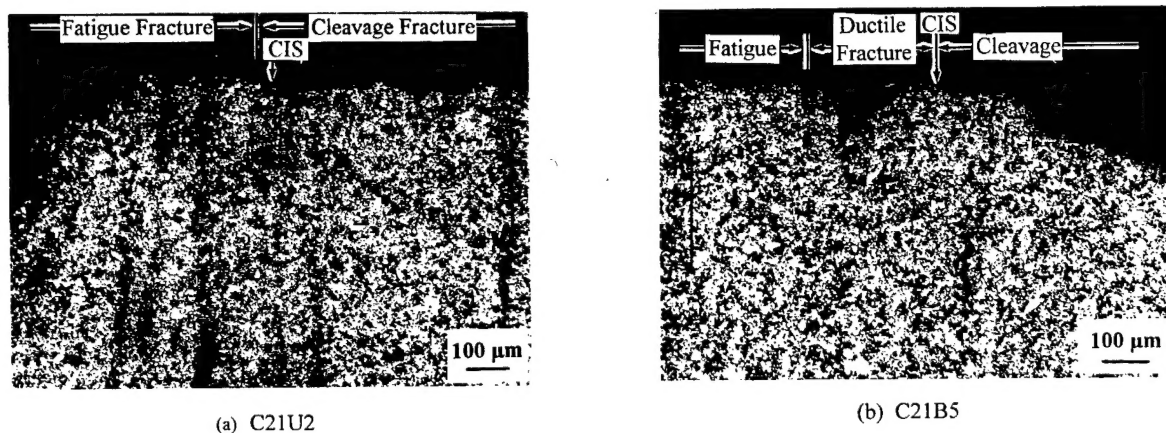
Figure 3: Optical micrographs of transverse sections showing the locations of the MCIR and the fatigue precrack tip for specimens (a) C21U2 and (b) C21B5.

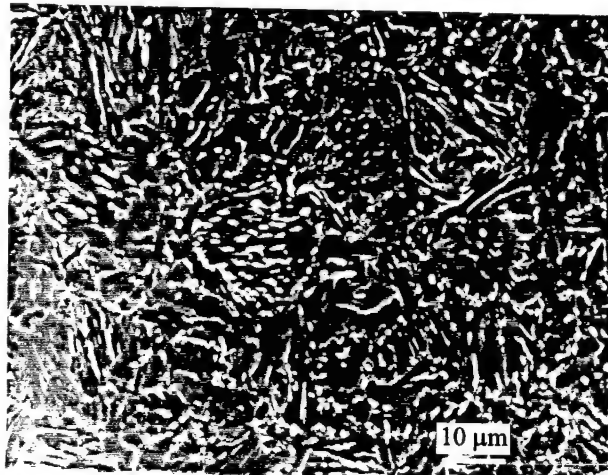
Figure 4c: An SEM micrograph of tempered martensitic or/and tempered bainitic structure of the light band in 4a.

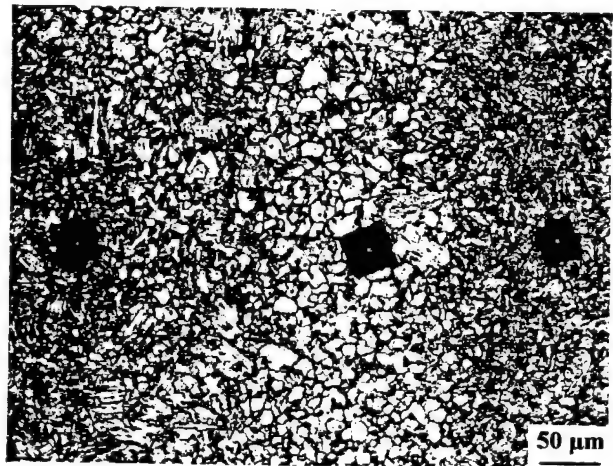
Figure 4d: An optical micrograph showing a significant difference in Vickers indentation size between the two microstructures.

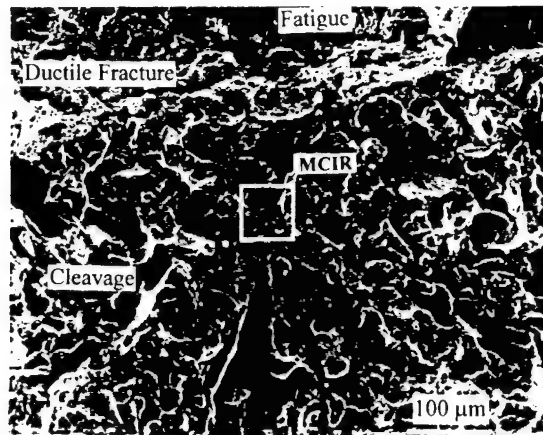
Figure 5a: A conventional SEM fractograph of specimen BB10 showing the location of the MCIR.

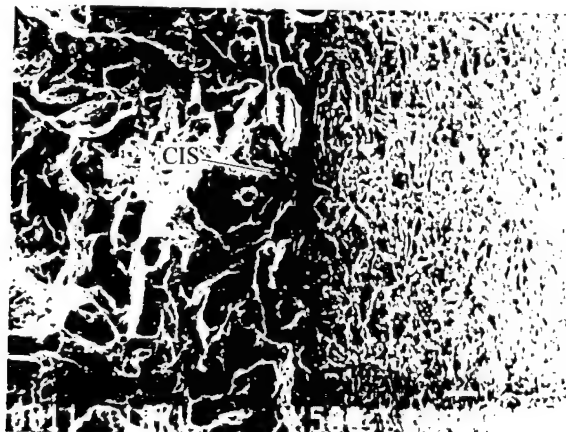
Figure 5c: An SSF fractograph: fracture surface and microstructure of the transverse section around the CIS illustrated simultaneously.

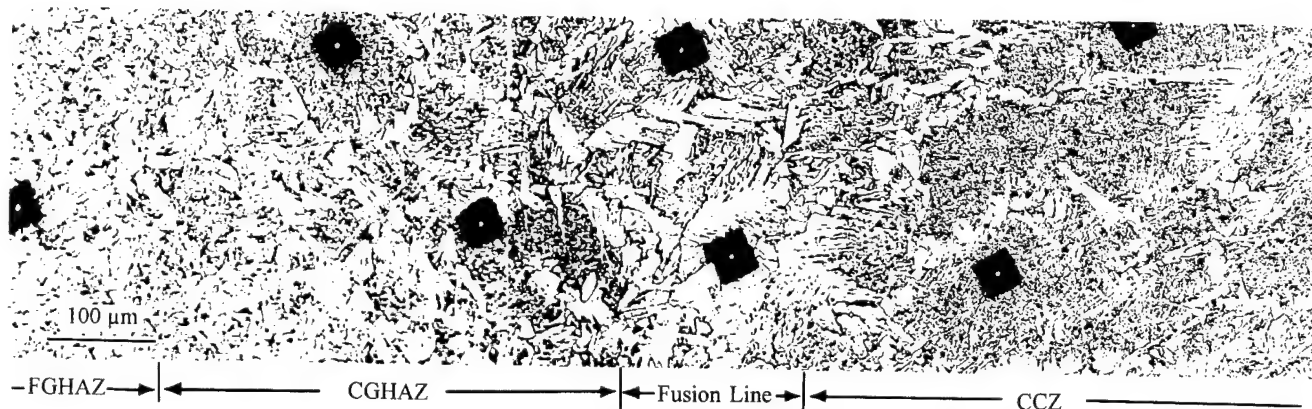
boundaries, Widmanstatten side plates, acicular ferrite, and carbide particle clusters. The features of these bands compared to the remainder of the weld bead microstructure suggest that this narrow region surrounding the fusion zone is the most brittle. Therefore, the CGHAZ and edge of the CCZ should serve as the preferential cleavage initiation region for this group of weldments.

Figure 8b: The microstructure surrounding the fusion line of one weld bead; line A-A in 8a.

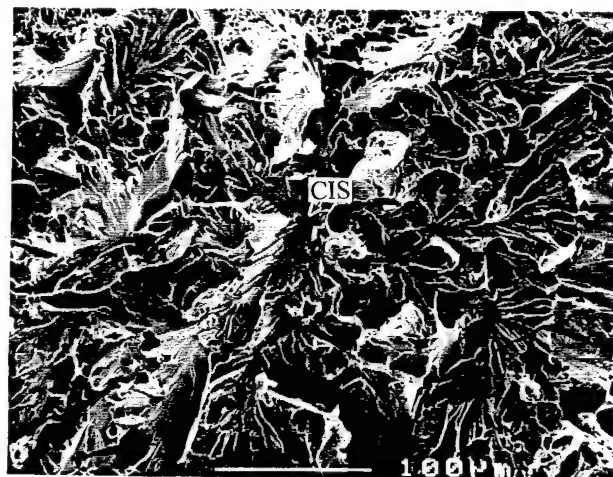
Figure 9b: An enlargement of the MCIR in 9a.

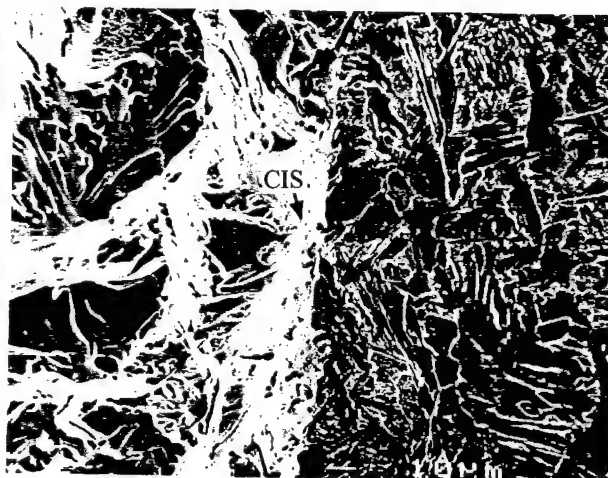
The SSF results indicated that the MCIS in four of the five sectioned GXK specimens was located at the edge of the CCZ, adjacent to the fusion line. Specimen GXK 62 is typical of these specimens. The unsectioned fracture surface of this specimen (Figure 9a) clearly indicates the dominant CIS. The focal point of the site (within the white box in Figure 9a) is enlarged in Figure 9b and the cleavage initiation site has been identified by the black arrow. A transverse section was then prepared approximately 10  $\mu\text{m}$  from the cleavage initiation site. Figure 9c shows the fracture surface and transverse section simultaneously after tilting the specimen 45° about the sectioning axis. In the figure, the small triangular cleavage facet near the cleavage initiation site (indicated by black arrow) was used to identify the location of the MCIS as the section was rotated to view solely the transverse microstructure surrounding the CIS and fatigue precrack (Figure 10). It is evident in Figures 9c and 10 that cleavage initiation was associated with long ferrite plates at the edge of the CCZ, adjacent to the fusion line. Further, it is evident that (1) the tip of the fatigue pre-crack was located in the middle of the CCZ; (2) ductile crack growth proceeded through the CCZ for approximately 1 mm without triggering cleavage cracking; and (3) cleavage was triggered only when the edge of the CC microstructure was sampled by the crack tip. As mentioned earlier, four of the five GXK specimens examined also exhibited cleavage initiation only within the CCZ, near the edge of the fusion line.

Figure 9c: Fracture surface and microstructure of the CIR region: tilted 45° about the section axis.

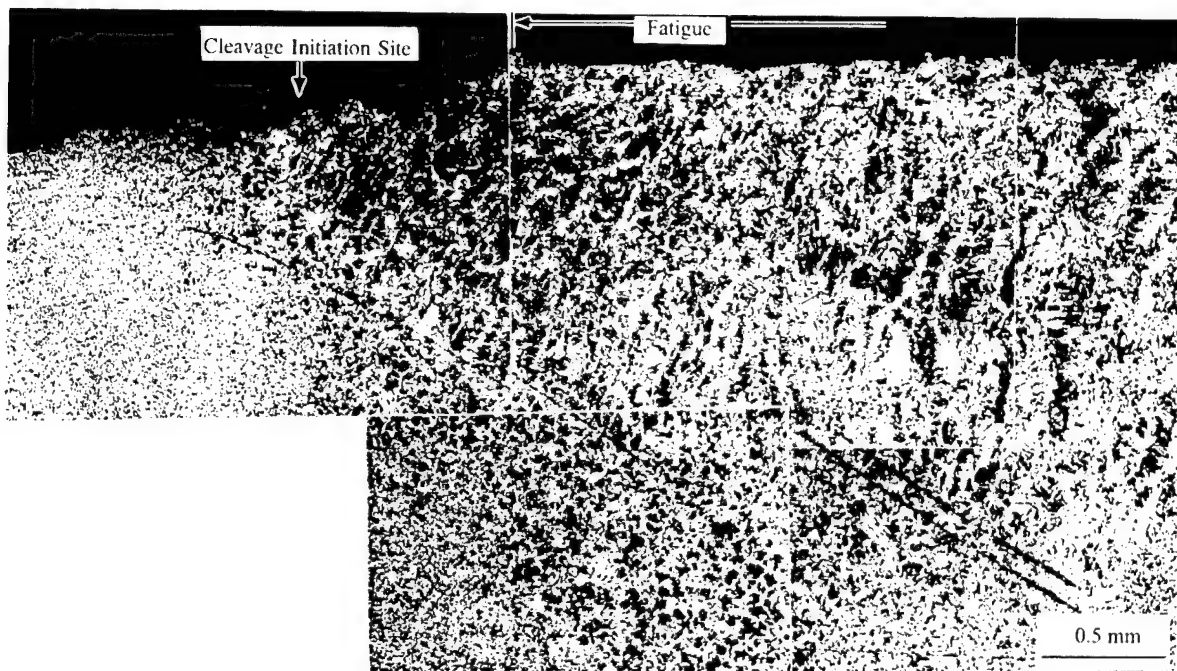
Figure 10: An optical micrograph of specimen GXK 62 showing the location of the fatigue precrack tip and the CIS with respect to the welding bead structure.

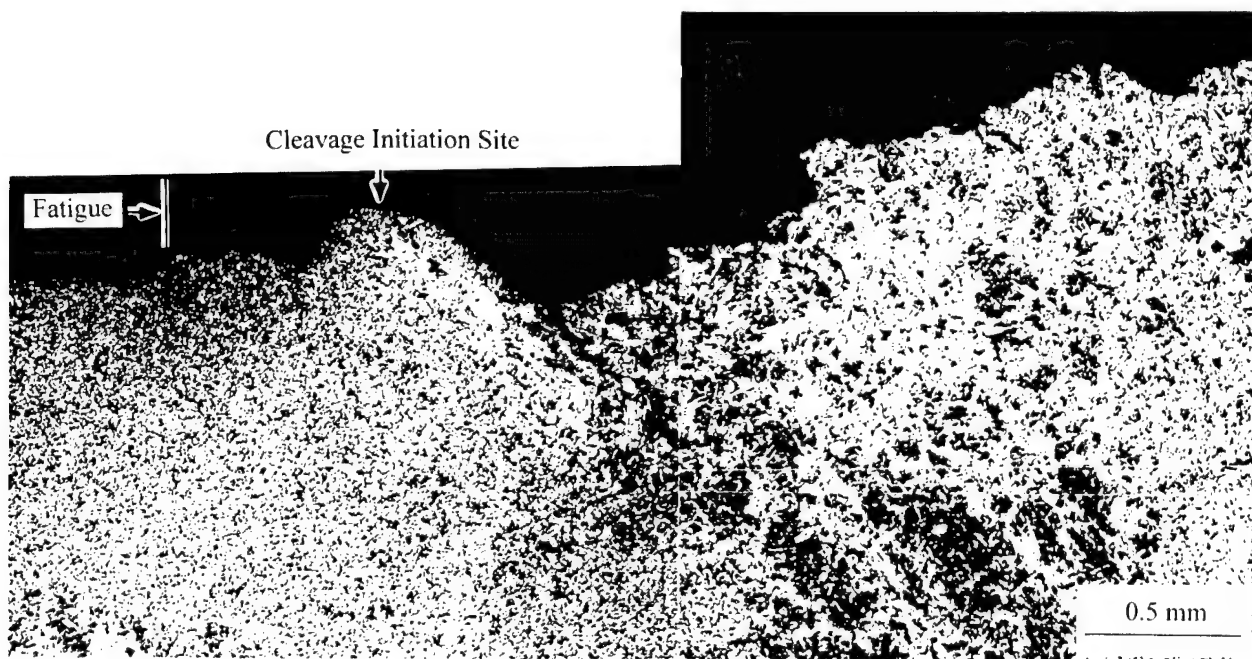
The only specimen analyzed that did not cleave within this region was GXK 59. The cleavage site was identified, and the transverse section was prepared as before. Once again, the transverse section was located within 10  $\mu\text{m}$  from the CIS. The final etched section is shown in Figure 11. The fatigue crack tip in this specimen was located within the FGHAZ of this weld pass. The crack initiated as a stable, ductile crack and propagated through the FGHAZ, toward the fusion line. Only when the crack reached the CGHAZ, did cleavage initiation occur. Therefore, although the edge of the CCZ was not the triggering site in this specimen, the other susceptible microstructural site was responsible.

Figure 11: An optical micrograph of specimen GXK 59 showing the location of the fatigue precrack tip and the CIS with respect to the welding bead structure.

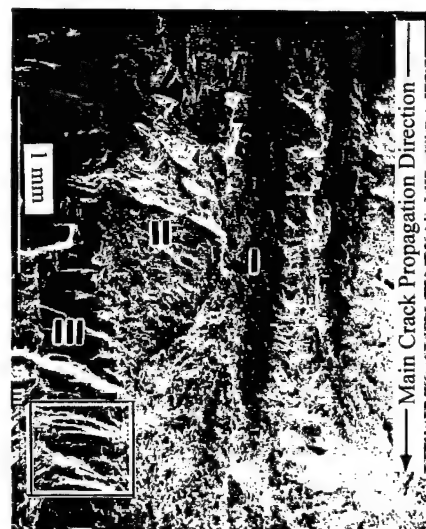
Figure 13a

Figure 13a: A conventional SEM fractograph of specimen SIP-26A showing three distinguishable features.

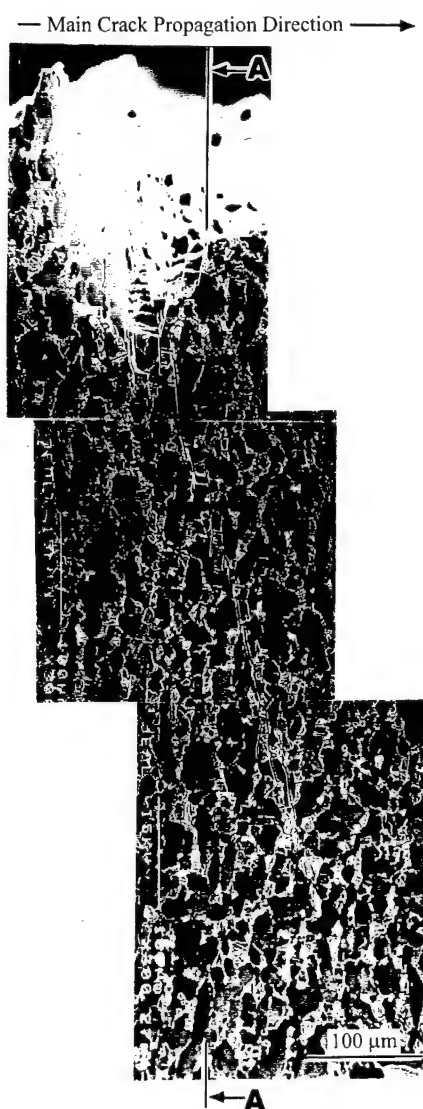
The SSF technique was again utilized to examine the usual transverse section (Figure 1) through a feature III region. These sections are revealed in Figures 14a and 14b and the acuity of these ledges becomes apparent; each is on the order of 100 - 200  $\mu\text{m}$  out of the fracture plane. Closer examination of one of the troughs reveals extensive out-of-plane cracking that follows elongated  $\alpha$  grains. A second SSF section was made perpendicular to the section in Figure 14b (section A-A) near the trough illustrated in this figure. The transverse cracking path is now clearly shown to propagate along elongated  $\alpha$  grains with a preferred orientation (Figure 14c). An enlargement of the trough (boxed area in Figure 14c) illustrates the coplanar nature of this cracking as shown in Figure 14d. The top-most plane is evident in the bottom portion of Figure 14d and is actually the polished and etched microstructure of section A-A (Figure 14b). The layers below this plane are the fracture surfaces of the secondary cracks that appear to the left of section A-A (Figure 14b). The correspondence between the crack surfaces and the microstructure is striking and indicates the crystallographic nature of this cracking, the relative weakness of this orientation, and the strong texture within this region.

Figure 14b: An enlargement of the boxed area in 14a showing the long vertical secondary cracks.

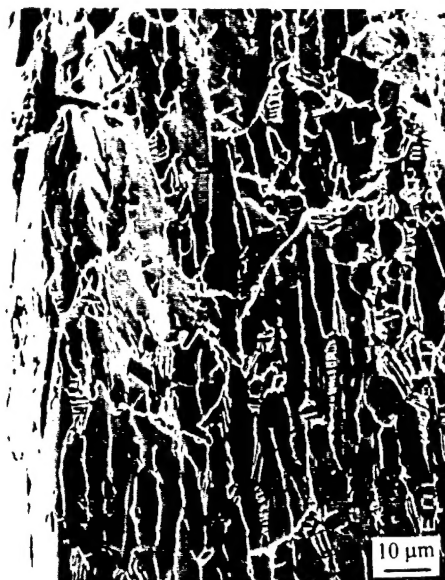
These pictures elucidate the correspondence between the secondary cracking path and the orientation of the elongated  $\alpha$  grains. The  $\alpha$  grain orientation texture was produced during the solidification process and was not eliminated by subsequent heat treatment. The crystallographic appearance of this cracking implies that a cleavage-type mechanism may govern this phenomenon. This out-of-plane cracking is not desirable because of both its brittle nature and the fact that it implies this microstructural orientation is much weaker than in the normal plane within these regions. The texture can be eliminated through proper solution heat treatments to form either randomly oriented, equiaxed  $\alpha$  grains mixed with  $(\alpha + \beta)$  constituents, or a fully transformed structure. A more homogeneous, isotropic, and stronger fracture performance should then be achievable.

Figure 14d: Enlargement of the boxed area in Figure 14c: a good correlation between etched microstructure and secondary cracking fracture planes is apparent.
